Title: 2019 Megasun Illumination System Modifications and Operating Procedure Updates

2019 MegaSun Illumination System

Modifications and Operating Procedure Updates

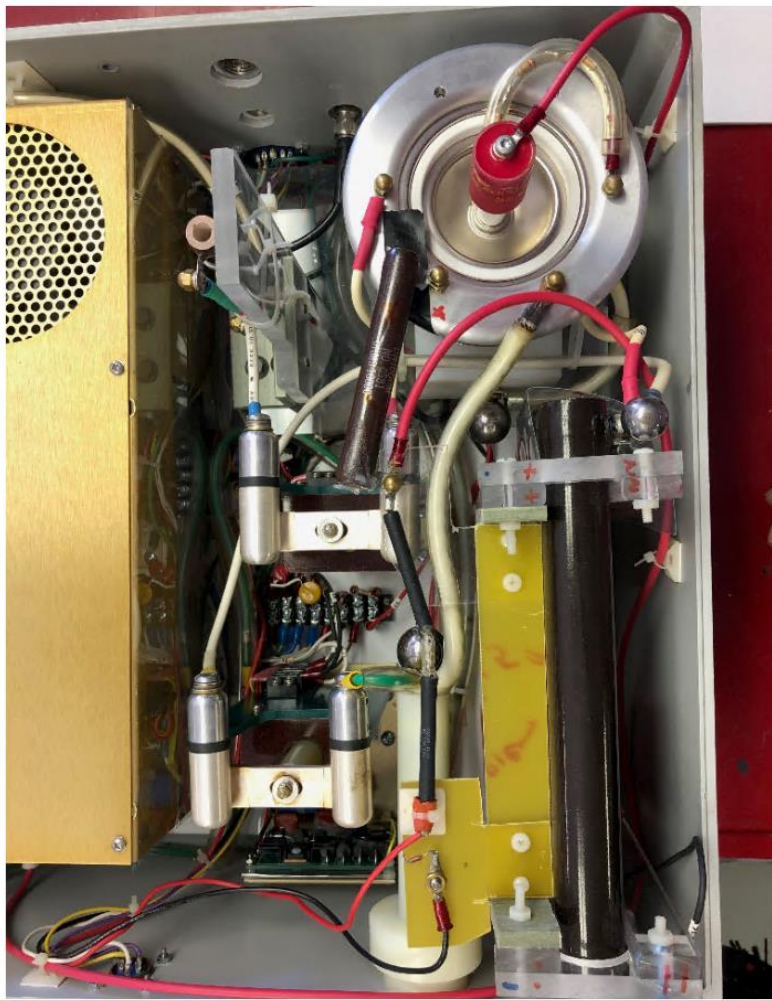
The Findings

- More than 8 ESO's from various divisions, including the head of our Electrical Safety Committee were present during the walk-down.
- Somewhere along the way, the 2001 system had been modified. It no longer had a "hard short" on one of the 2 ross relays, which remove energy from the system via facility ground. Instead, a resistor was placed inline with the path to ground.
- This design was lacking a HV Output Disable Pin
- Modifications would need to be made in order to operate this model within the guidance of its hazard class, defined by the LANL Electrical Safety Committee
